**Executive Summary of Urgent Field Survey of Earthquake and Tsunami Disasters
by the 2011 off the Pacific coast of Tohoku Earthquake**

Port and Airport Research Institute (PARI) has accomplished urgent field survey of devastating multiple disasters of earthquake and tsunami by the 2011 off the Pacific coast of Tohoku Earthquake which occurred in March 11, 2011, at 14:46 local time, rating a magnitude of 9.0.

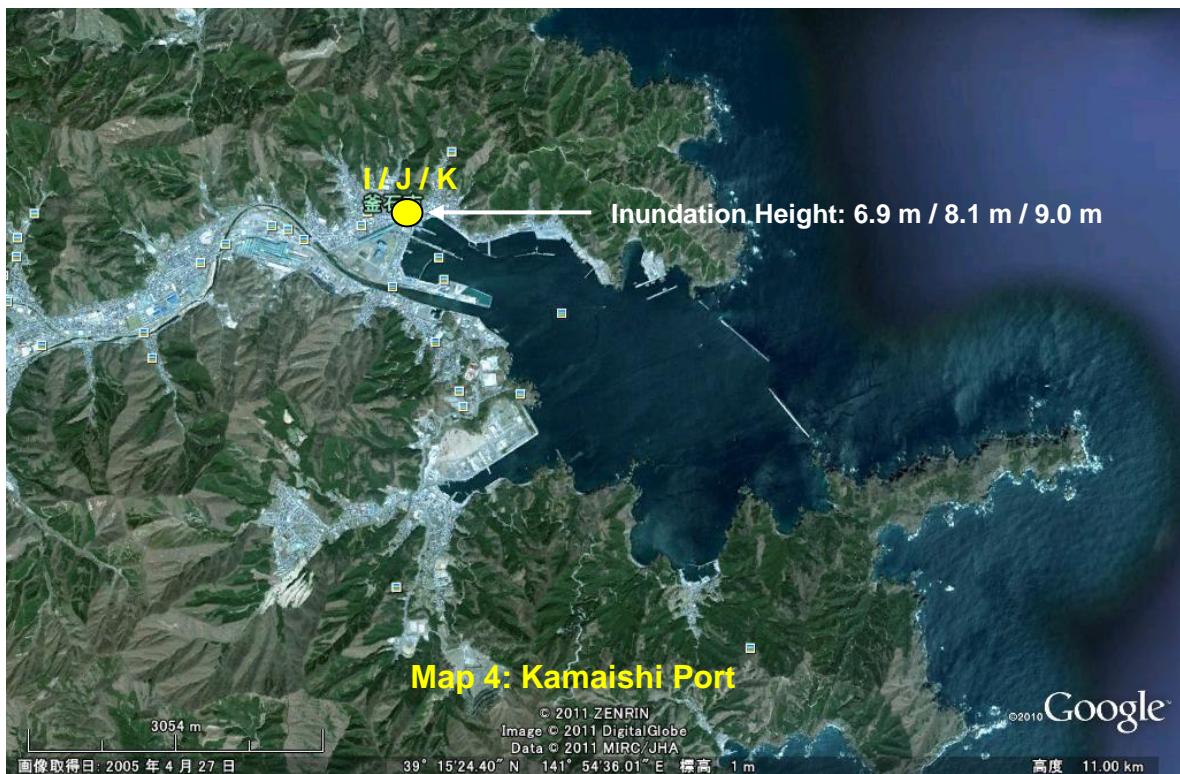
3. Kamaishi Port

Inundation heights of 6.9 to 9.0 m were observed at the points **I**, **J**, and **K** in the inner port area. Most wooden houses were floated out completely. Reinforced concrete (RC) buildings and large-scale grain silos were damaged but not collapsed. A number of vehicles together with destroyed houses were observed floated out on the road.

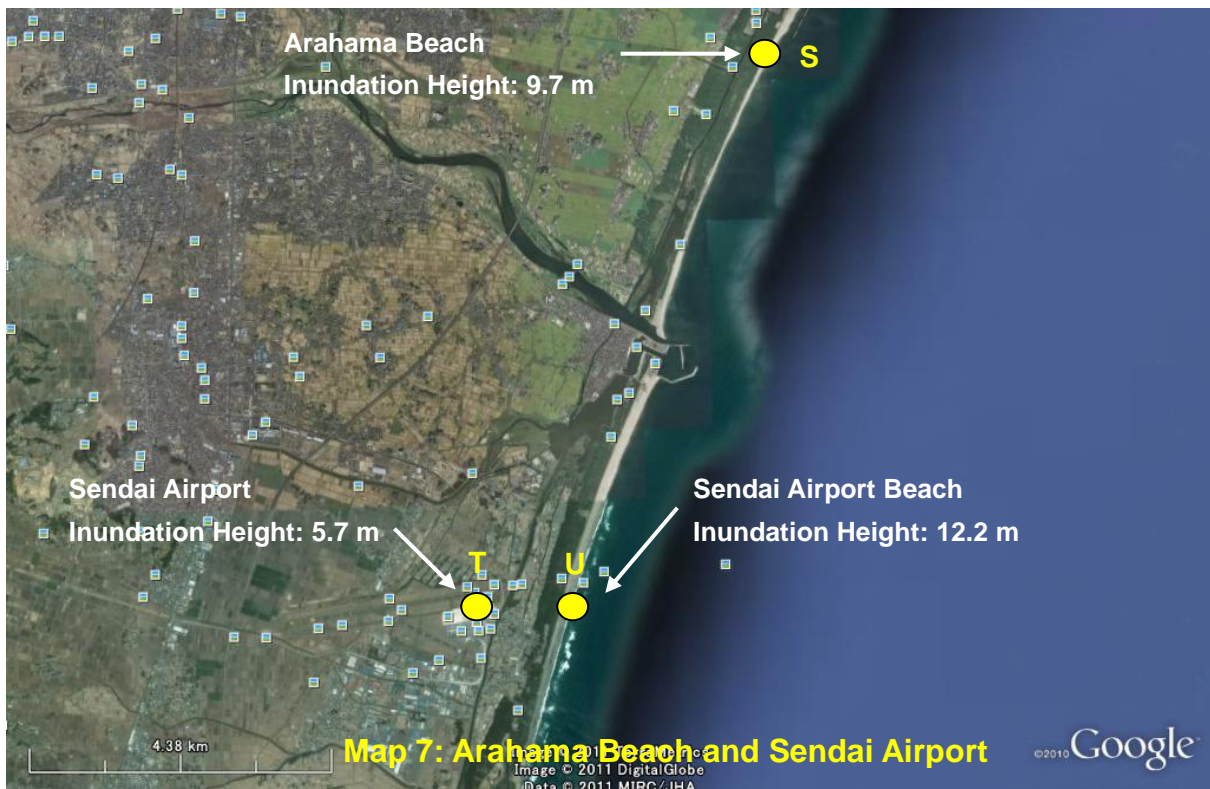
6. Arahama Beach and Sendai Airport

Inundation height of 9.7 m was observed at the point **S** on the Arahama beach and no significant scours were observed behind the coastal dike. However, at the point **U** on the front beach of Sendai airport, where the inundation height was 12.2 m, significant scours were observed behind the coastal dike resulting in its collapse. Inundation height of 5.7 m was observed at the point **T** in the Sendai airport building.
