港湾空港技術研究所 報告

Vol.50 No.1 March 2011

Effect of Surface Improvement Layer on Internal Stability of Group Column Type Deep Mixing Improved Ground under Embankment Loading

Masaki KITAZUME*

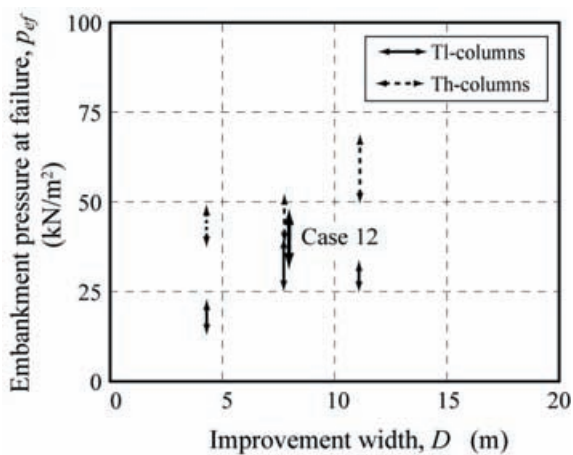
Fig. 5. Embankment pressure at ground failure and improvement width.

tions, the forefront column always failed first, irrespective of the surface improvement layer. A similar phenomenon was found irrespective of the column strength and the number of column rows (Kitazume and Maruyama, 2007). Here, ground failure is defined as the rupture breaking failure of the forefront column. The embankment pressure at ground failure, p_{ef} , is summarized in Table 2, and the relationship to the improvement width, D , is plotted in Fig. 5 together with the other test cases. As discussed in Fig. 4, the model columns failed one by one at several embankment pressures even in the forefront column. The pressure ranges at which the forefront columns failed are plotted as arrows. It can be seen that p_{ef} increased with increasing improvement width, D , and p_{ef} in Case 12 was about 15 to 35% larger than that in Case 7.

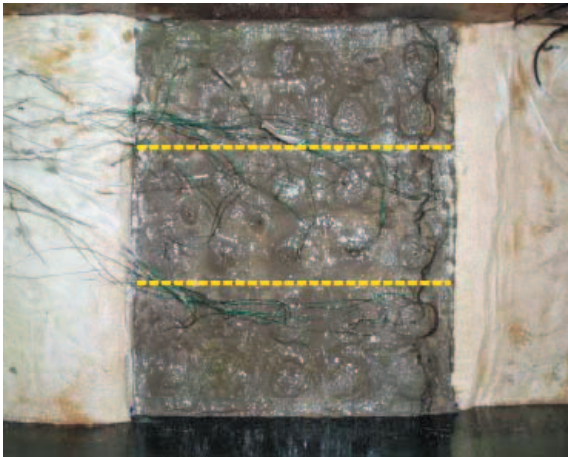
Fig. 7. Surface improvement layer failure.

In Case 12, two carbon rods were embedded parallel to the specimen length in the surface improvement layer to detect the failure, similar to the columns. Figure 7 shows a top view of the surface improvement layer after the embankment loading, with the embedded position of the carbon rods indicated by broken yellow lines. The measurements of the rods show that the surface layer was broken at the rear side first and then at the window side at an embankment pressure of 30.3 and 40.8 kN/m², respectively. A tensile crack developed just behind the rearmost column and extended over the entire length of the layer. However, no failure took place in other parts of the layer.

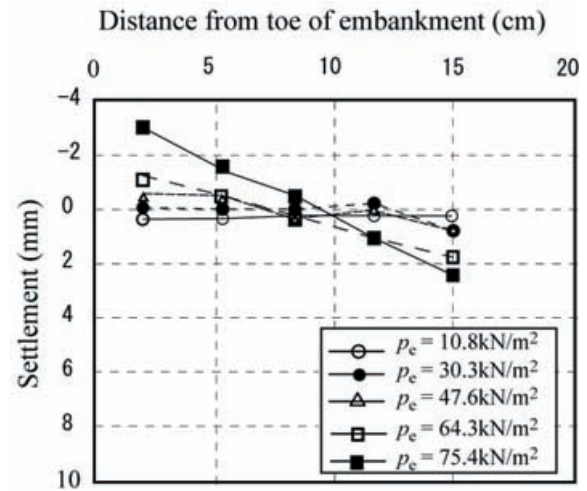
(a) Improved ground (Case 12)

Fig. 11. Vertical displacement distribution.

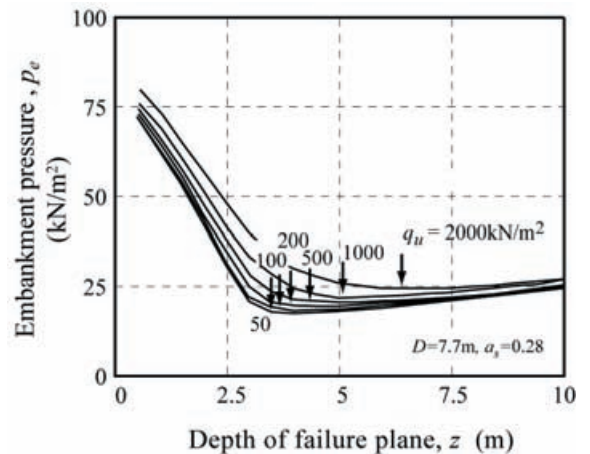
Fig. 15. Assumed depth of failure plane and embankment pressure for Case 12.

Figure 15 shows the relationship between the assumed depth of the failure plane, z , and p_e for the improved ground with $D = 7.7$ m and $a_s = 0.28$. The relationship for various column strengths is plotted in the figure and shows a concave shape, irrespective of the q_u value. The $z_{f,bending}$ giving $p_{ef,bending}$, as shown by the arrow, increases slightly with increasing q_u . The relationship is a relatively flat concave shape irrespective of the column strength, which means that the $z_{f,bending}$ can easily be variable due to a slight change in ground conditions. It can be seen that $p_{ef,bending}$ also increases slightly with increasing q_u .

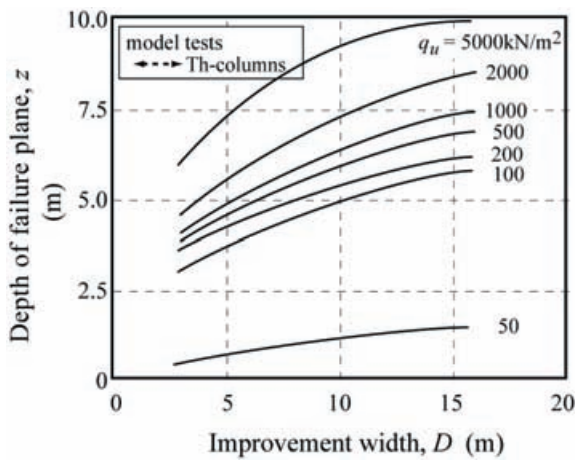
(a) Improved ground with surface improvement layer

(b) Improved ground without surface improvement layer
Fig. 16. Failure depth and improved width of failure plane (a).

A series of calculations was carried out for various improvement widths and column strengths, and the relationship between D and $z_{f,bending}$ is shown in Fig. 16(a) for the improved ground with the surface improvement layer. The $z_{f,bending}$ value increases monotonically with increasing D and with increasing q_u . It is of interest to note that the $z_{f,bending}$ value is comparatively small for q_u of 50 kN/m² but becomes much larger when q_u is 100 kN/m² or higher. Figure 16(b) shows an example for the improved ground without the surface improvement layer for comparison (Kitazume and Maruyama, 2007). The effect of D and q_u on $z_{f,bending}$ for the improved ground with the surface improvement layer is much more dominant than without the surface layer.

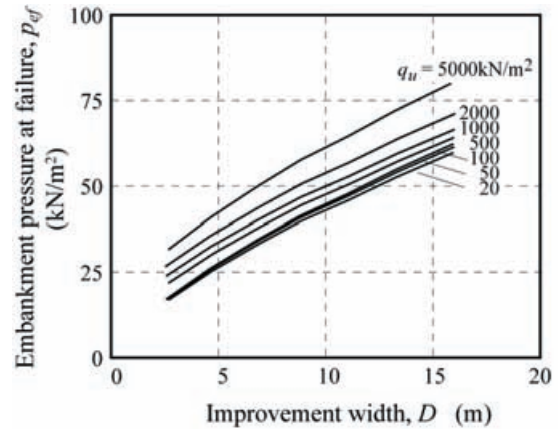
(a) Improved ground with surface improvement layer

Fig. 17. Embankment pressure at ground failure and improvement width of failure plane (a).

The $p_{ef,bending}$ value is shown along with D in Fig. 17 for the improved ground with and without the surface improvement layer. As shown in Fig. 17(a), the $p_{ef,bending}$ value increases monotonically with increasing D and q_u for the ground with the surface improvement layer. A similar phenomenon can also be seen for the ground without the surface improvement layer, as shown in Fig. 17(b). The improvement width, D , has a dominant effect on $p_{ef,bending}$,

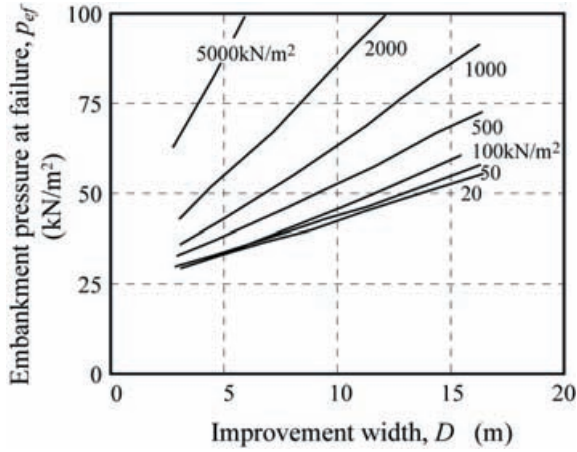
Fig. 18. Embankment pressure at ground failure and improvement width of failure plane (b).

As discussed in Fig. 14, the clockwise moment is induced at the top of the column due to the effect of the surface improvement layer. Its magnitude, M_{sl} , formulated as Eq. (1), increases linearly with increasing embankment pressure. In the calculation, the column is assumed to fail when the induced tensile stress due to M_{sl} reaches the ultimate bending strength, σ_b , of the DM column. The embankment pressure at the column top failure, p_{ef} , is calculated and plotted in Fig. 18. The figure shows that p_{ef} increases with increasing improvement width, D , and the column strength, q_u . In a comparison with Fig. 17(a), the effect of q_u on p_{ef} is much more dominant in Fig. 18. As the induced moment, M_{sl} , is not influenced by the column strength, q_u , the embankment pressure at failure for the column top failure increases considerably with increasing q_u .

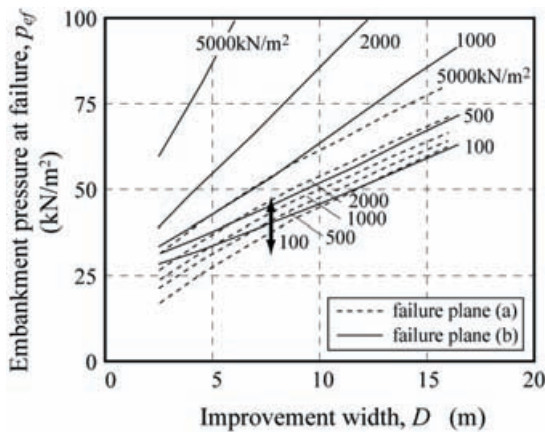
Fig. 19. Embankment pressure at ground failure and improvement width for combined planes.

It is reasonable that the DM column would fail by either of the two failure patterns that give the minimum capacity under certain conditions. Figure 19 shows the combination of failure criteria (a) and (b). It was found that p_{ef} increases with increasing D and q_u , and p_{ef} for the two failure criteria is almost of the same order as in the case where q_u is lower than about 500 kN/m². As the column strength of the test case was about 400 kN/m², as shown in Table 1, it can be estimated that two failures took place in the columns at almost the same time at deep and shallow depths. The criterion for failure plane (a) gives a lower p_{ef} value in almost all the cases in this study.

In the figure, the model test results are also plotted as arrows. The test results are plotted within the calculation for various p_{ef} values, showing a reasonable estimation.

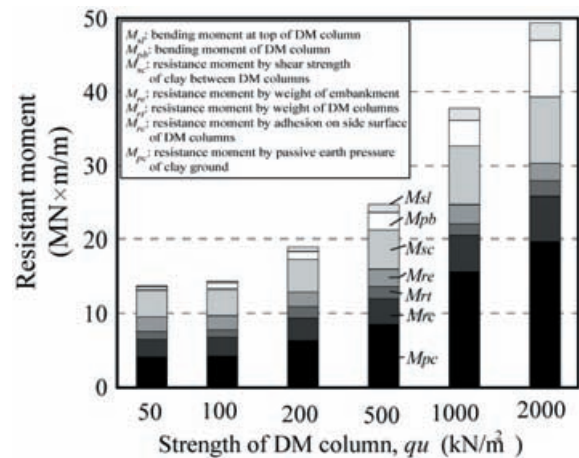
Fig. 20. Resistance moment components.

In order to investigate the effect of the surface improvement layer, the resistance moment components for failure plane (a) are shown in Fig. 20. The passive earth pressure component of the resistance moment, M_{pc} , increases with increasing q_u due to increasing $z_{f,bending}$. The passive earth pressure component, M_{pc} , has a dominant role in the entire resistance load throughout D . Its degree increases with decreasing D and with increasing q_u . The component of the clay strength between the columns, M_{sc} , also has a dominant role. However, the surface improvement layer component, M_{sl} , has quite a small role of about 5% of the entire resistance.
